Learning from Earthquakes

The Japan Tohoku Tsunami of March 11, 2011

This report summarizes the field reconnaissance observations of the EERI team led by Lori Dengler, Humboldt State University, and Megumi Sugimoto, Earthquake Research Institute, University of Tokyo, who visited the hardest-hit areas of Miyagi and Iwate Prefectures in April and May 2011. It also includes observations from two International Tsunami Survey Teams (ITSTs) deployed to study tsunami deposits. The first team visited the Sendai area in May and was made up of Kazuhisa Goto, Chiba Institute of Technology; Shigehiro Fujino, University of Tsukuba; Wittek Szczucinski, Adam Mickiewicz University, Poland; Yuichi Nishimura, Hokkaido University; Daisuke Sugawara, Tohoku University; Eko Yulianto, Indonesian Institute of Science; Rob Witter, Oregon Department of Geology and Mineral Industries; Catherine Chagué-Goff, University of New South Wales, Australia; Masaki Yamada, University of Tsukuba; Dave Tappin, British Geological Survey; Bruce Richmond, U.S. Geological Survey (USGS); and Bruce Jaffe, USGS. In August, Rick Wilson, California Geological Survey; Robert Weiss, Virginia Tech University; James Goff, Universi

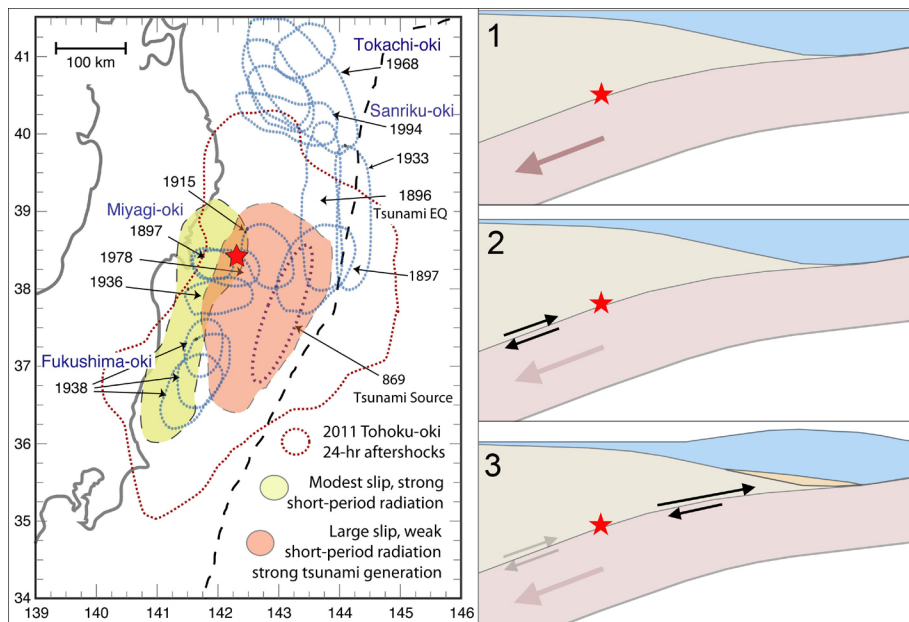
Figure 2. Source characteristics of the March 11 earthquake. Left: March 11 epicenter and rupture area. Also shown is the aftershock region and the source areas of previous historical earthquake (adapted from Kanamori, 2011). Right: simplified cartoon of the rupture sequence and tsunami generation. Yellow zone shows the initial rupture down-dip of the epicenter (2). After about 75 seconds, the rupture migrated up-dip of the epicenter (pink zone). The second phase of rupture propagated slowly and produced very large slip (3).

yellow area) and was characterized by normal rupture velocities and moderate slip (Kanamori, 2011). It produced strong ground shaking in much of the Tohoku region. After about 75 seconds, the rupture moved up-dip of the hypocenter into the much weaker rocks of the megathrust accretionary prism. This rupture (Figure 2, pink area) was characteristic of a “tsunami earthquake”: relatively slow rupture velocity with weak ground shaking and very large slip. Some models (Ozawa et al., 2011; Pollitz et al., 2011) suggest the peak slip may have exceeded 50 m in some areas of this zone. This second phase of the earthquake likely accounted for the majority of the tsunami generation.

The main shock initiated about 43 km WSW of the March 9 foreshock. The initial zone of rupture was down-dip of the hypocenter (Figure 2,

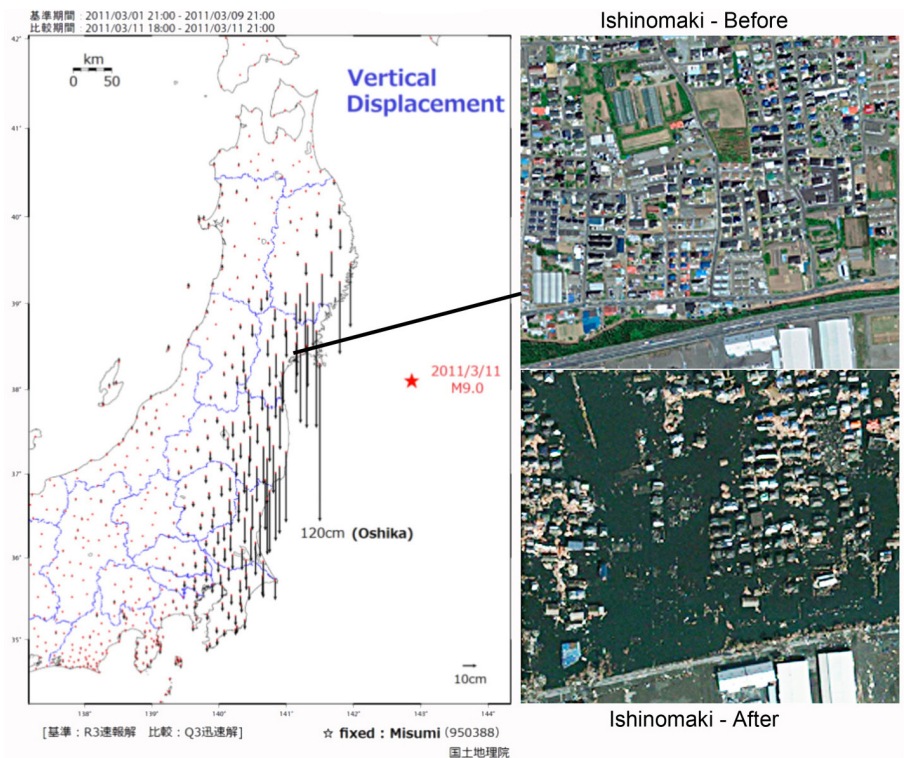
Figure 3. Left: vertical displacement field of the Tohoku earthquake from GPS measurements provided by the Geospatial Institute of Japan (2011). All coastal areas from Iwate to Chiba subsided during the earthquake. In this preliminary map, the peak vertical displacement (1.2 m) was in the Oshika district of Miyagi Prefecture near Onagawa City. Right: Google Earth images taken before and after the earthquake show the impacts of subsidence at Ishinomaki.

horizontal and vertical changes (Grapenthin and Freymueller, 2011). There was subsidence along the Tohoku coast after the earthquake, with some areas dropping down more than a meter (Figure 3a). As a result, some low-lying areas are now below sea level (Figure 3b) and parts of the region are more susceptible to tsunami inundation.

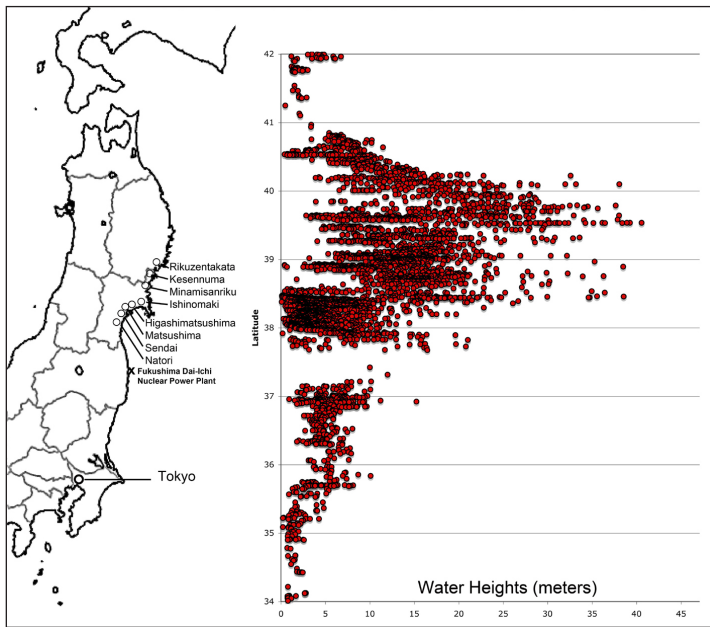
Figure 4. Measured tsunami water heights as a function of latitude from post-tsunami surveys, as compiled by the NGDC (2011). The gap in measurement in Fukushima Prefecture is due to access restrictions associated with the Fukushima Dai-ichi nuclear power plant (shown by the x).

Miyagi prefectures. On the broad plain that characterizes the coast of Miyagi Prefecture south of Sendai, peak water heights averaged 8-10 m. There were significant tsunami impacts as far south as Chiba Prefecture.

Over 5,400 water level measurements have been collected along 2,000 km of the Japanese coastline as of the time of this report (Tohoku Earthquake Tsunami Joint Survey Group, 2011), making this the largest collection of tsunami height measurements for a single tsunami event. The data have been summarized in reports of the IOC/UNESCO intergovernmental commission on tsunamis (2011) and have also been posted at NOAA's National Geophysical Data Center (NGDC) Tsunami Data Base (2011). Figure 4 shows the NGDC water height compilation. The highest water levels (38.9 m) at Aneyoshi Bay south of Miyako City in Iwate Prefecture were the maximum ever measured in a Japan tsunami. Water heights were close to or exceeded 20 m in most populated coastal communities in Iwate and northern

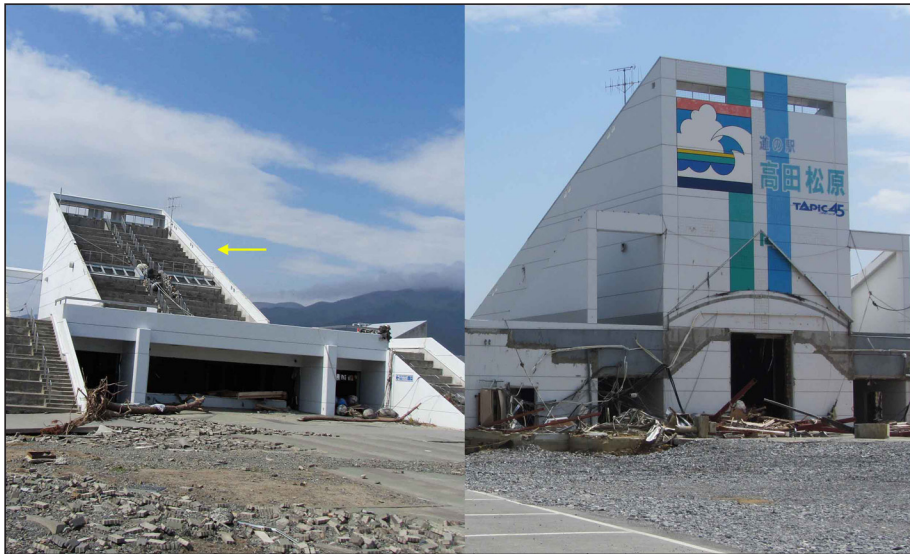
Figure 5. Tsunami evacuation building, Rikuzentakata. Measured water levels were 19 m, shown by the yellow arrow (photos: L. Dengler).

the Kesen River in southern Iwate Prefecture. The tsunami reached heights of 19 meters, reaching the fifth floor elevation in much of the central part of the city, destroying all structures in this area except for two large reinforced concrete buildings: the seven-story Capital Hotel and the adjacent tsunami evacuation building (Figure 5). The evacuation building featured a unique design, with exterior stairs leading up to a series of concrete seat platforms. The structure survived even though water heights exceeded the design tsunami, and only the two or three uppermost rows were above the water height and provided life safety.

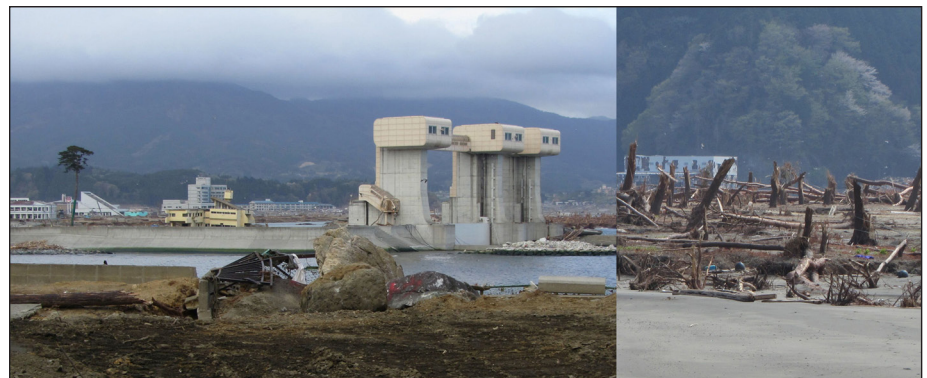
Figure 6. Left: the sole surviving pine tree out of a forest of 70,000 trees planted to protect the Rikuzentakata coast from tsunamis and storm surge. The towers on the left are part of the tsunami gates built to prevent tsunami surges from flooding the Kesen River. Right: the remains of the pine forest. Mature pine tree trunks were 20-40 cm in diameter and typically snapped 1-2 m above the ground (photos: L. Dengler).

Rikuzentakata was typical of many cities in the Tohoku region where forests of pine trees had been planted along the coast to provide protection from both storm waves and tsunami surges. The trees in Rikuzentakata were mature, with diameters of 25 to 40 cm. With one notable exception, all of the estimated 70,000 trees on the Rikuzentakata coast were destroyed by the tsunami (Figure 6). The one surviving tree, called “the tree of hope,” has become a national symbol of resilience, featured in songs and poems. Unfortunately, the tree is showing signs of stress caused by the high levels of salt in the soil and may not survive.

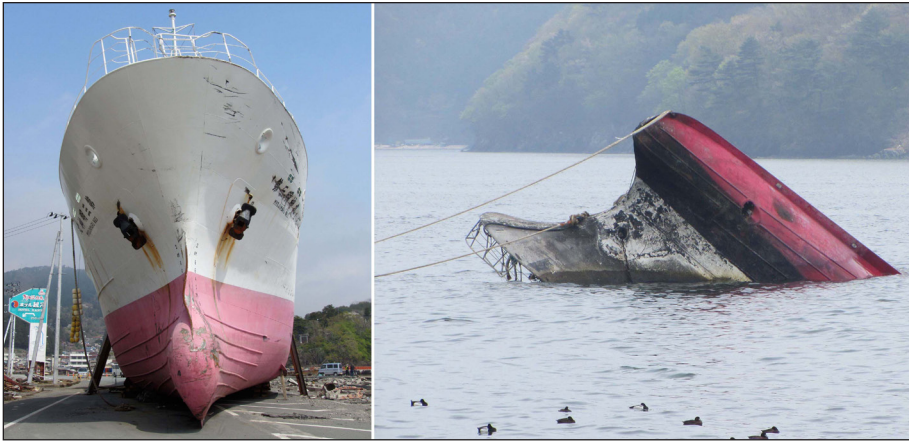
Figure 7. The tsunami deposited boats in many areas of Kesennuma City and left others to burn or sink in Kesennuma Bay (photos: L. Dengler).

Kesennuma City (population 73,000) is located at the head of Kesennuma Bay and, before the tsunami, was a thriving commercial fishing port and the center of Japan's shark fin trade. Many of the large packing plants along the harbor suffered damage due to liquefaction. Dozens of boats were torn from moorings, some of which were deposited inland, and others sank in the bay (Figure 7). The long-term ecological impacts of the fuel and other hazardous materials released in the bay are difficult to predict.

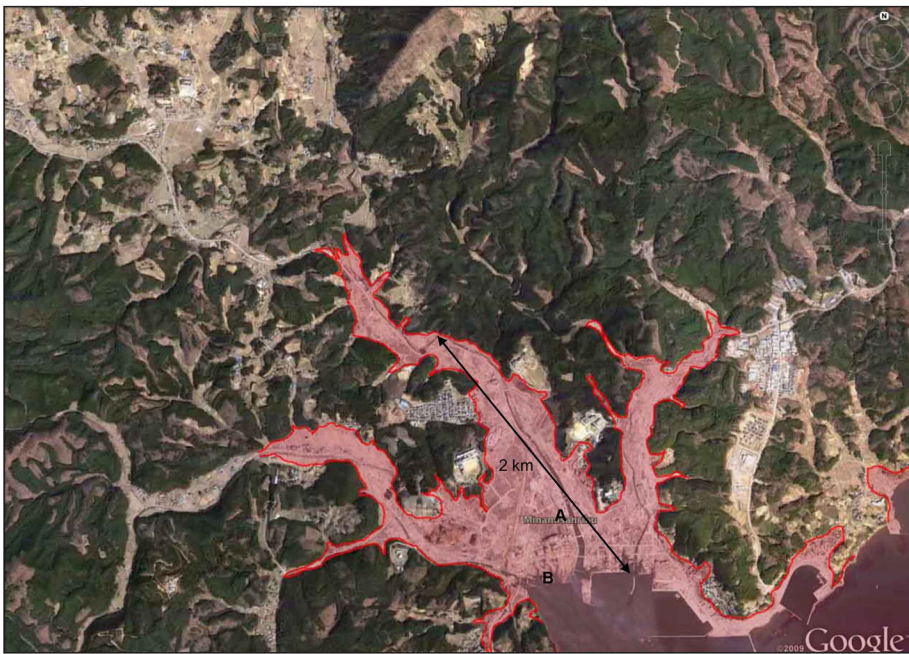
Figure 8. The approximate inundation zone in Minamisanriku Town. The tsunami surges destroyed the town center and went up the narrow Hachiman River (center) and the Sakura River (on left) and the Oretate River (on right). Black arrow is 2 km long. (A) marks the location of the disaster management building shown in Figure 10 and (B) shows the tsunami evacuation building in Figure 26. The gates shown in Figure 9 are just to the right of B. The inundation area shown here (and in Figures 12 and 15) is based on Google earth imagery and may change when data from field teams is included.

Minamisanriku Town (population 17,000) had gained an international reputation for tsunami preparedness before the tsunami and was a featured field trip stop for tsunami experts. The three rivers flowing through the town featured tsunami gates that could be shut in 15 minutes to keep the tsunami from penetrating inland up the river channels. Figure 8 is an approximation of the inundation zone, showing that the tsunami extended nearly 3 km up the Hachiman River and nearly 2 km up the adjacent river valleys. Officials successfully lowered the gates on March 11 (Figure 9), but the adjacent sea walls were overtopped and undermined, and did not prevent the city from being flooded. An estimated 31 of 80 designated tsunami evacuation buildings were destroyed (*Japan Times*, 2011). At the Disaster Management Center (Figure 10), more than 30 officials, including the town mayor, gathered on the rooftop during the tsunami event, and twenty died (*Asahi Shimbun*, 2011). Miki Ando, a municipal official responsible for broadcasting emergency information to the public, remained at her post on the second floor of the building and continued broadcasting announcements; she was credited by many for saving their lives as they heeded her warnings to get to higher ground, but she did not survive.

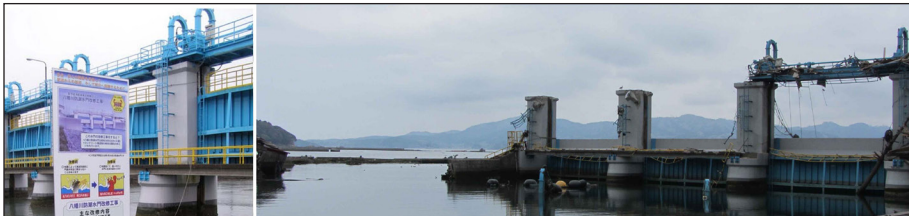
Figure 9. Left: gates on the Hachiman River, Minamisanriku, in April 2010 in the up position (photo courtesy of J. Bourgeois). Right: the same gates in May 2011 after the tsunami. They closed before the tsunami struck, but failure of the sea walls negated their effectiveness (photo: L. Dengler).

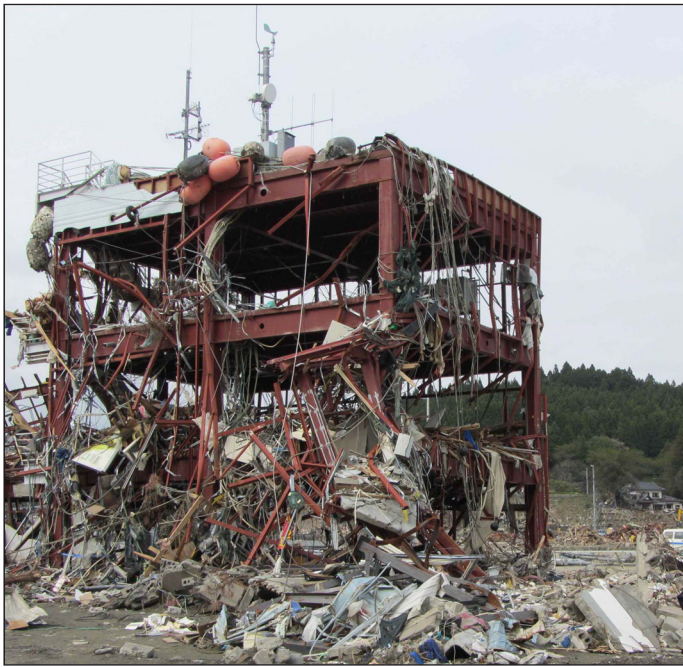
Figure 10. The disaster management headquarters for the town of Minamisanriku. About 30 officials gathered on the upper floor and roof on March 11. The tsunami completely flooded the structure and only 11 people survived. Note the location of high ground in the background (photo: L. Dengler).

sanriku Disaster Management Building shows the structure fully engulfed at 3:35 p.m., 48 minutes after the earthquake. Analysis of the voluminous set of photographs and video imagery taken of the tsunami, and more detailed study of tide gauge recordings, should provide better constraints on the time of arrival.

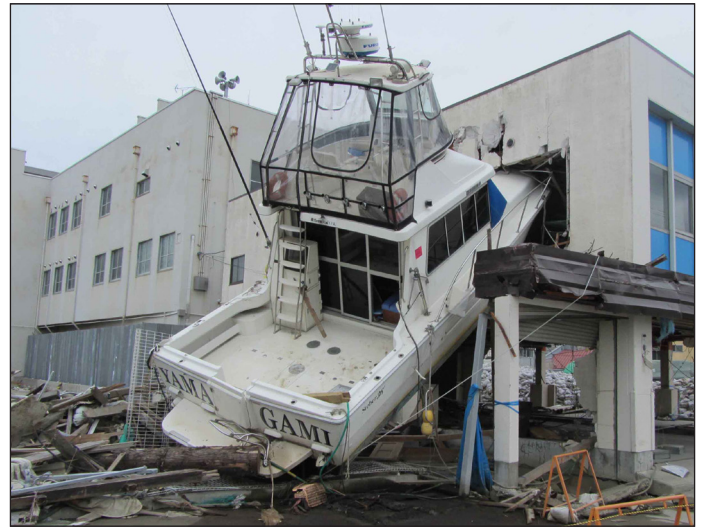
Figure 11. The inundation level in this area of Ishinomaki City was at the base of the second floor, but large objects in the water such as the boat shown caused extensive damage above the flow depth (photo: L. Dengler).

the rice trade. The main port facilities are located to the southwest of the population center and experienced water heights in the 4.5 to 5 meter range (PARI, 2011). Warehouses and reinforced concrete buildings suffered some damage but did not collapse. The port was nearly fully operational in May. Much of the rest of the city was very badly damaged and, because of the large exposed population, had the highest casualty total of any community in the Tohoku region. The large amount of debris in the water, including boats, caused some areas to be damaged that were above the inundation level (Figure 11).

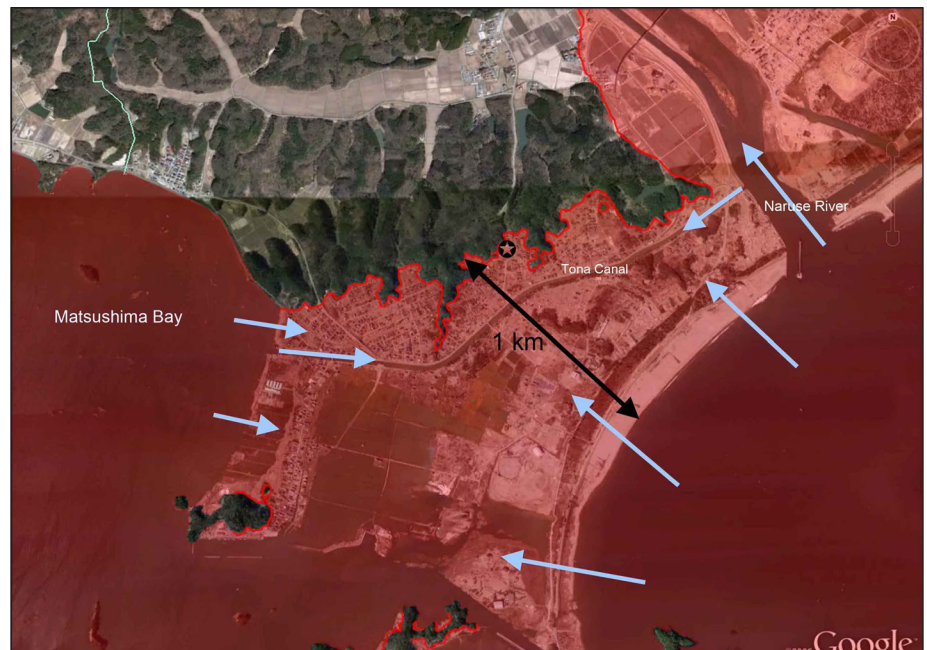
Figure 12. Approximate inundation area in the west area of Higashimatsushima City. This region was particularly vulnerable because the tsunami attacked from several directions. The star marks the location of the evacuation building shown in Figure 13. Note its proximity to higher ground on the hillside.

Higashimatsushima City (population 34,000) is located in the transitional zone between the much steeper terrain to the north and the broad, low-lying Sendai plain to the south. This city was particularly vulnerable, as tsunami surges attacked it from four different sources: the coast, the Naruse River, the Tona Canal, and Matsushima Bay (Fig-

ure 12). Parts of the city south of the Tona Canal had no direct access to high ground. One of the designated evacuation sites (Figure 13) was the multipurpose room adjacent to an elementary school. The elementary school was a

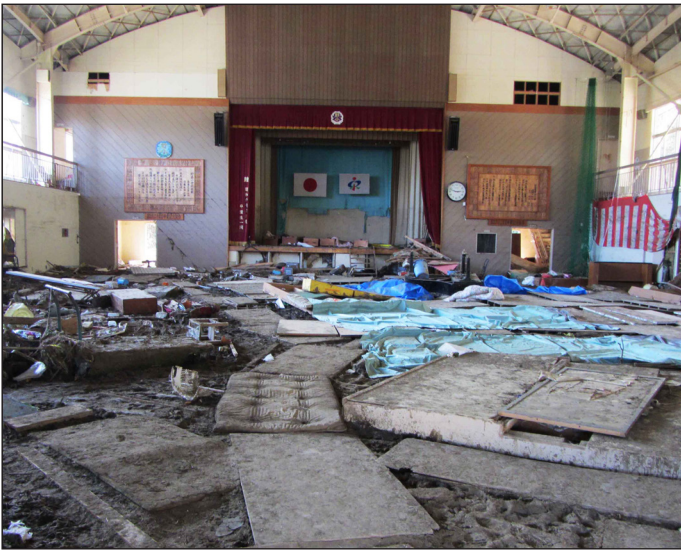
Figure 13. The multipurpose room of the Higashimatsushima elementary school, where 200 people gathered after the earthquake. The site was flooded to the base of the windows and most of the evacuees did not survive. The floor was used as morgue after the tsunami (photo: L. Dengler).

three-story building and the upper floors were above the inundation zone; however, it was not used for vertical evacuation, perhaps because the stairways were inside the building and would not have been accessible if the building were closed. An estimated 200 people gathered in the multipurpose room after the earthquake, but it did not

provide protection as the water level reached the base of the windows, and only a few people were able to get to safety on the ledge next to the windows. This site was located at the base of a hill where everyone could have reached high ground had they walked a few more minutes. One family of survivors lived close to the evacuation site, but they had only recently moved to the area and weren't aware of the designated building. Instead, they headed up the hillside behind their house after the earthquake and were able to see the waves approaching and to move up the hill when it became clear that the tsunami was very large.

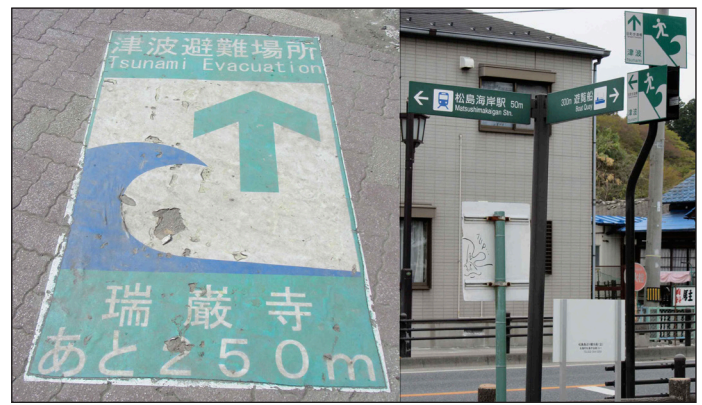
Figure 14. Tsunami evacuation route signs in Matsushima Town (photo: L. Dengler).

Matsushima Town (population 4,000) overlooks Matsushima Bay and is considered to have one of Japan's most famous views. The bay protected the town from the brunt of the tsunami, and water heights reached only 2.5 m, with flooding extending into the ground floors of buildings near the waterfront. Because of the large tourist population, the town has numerous tsunami evacuation route signs, some painted on the sidewalk for

an easy visual guide (Figure 14).

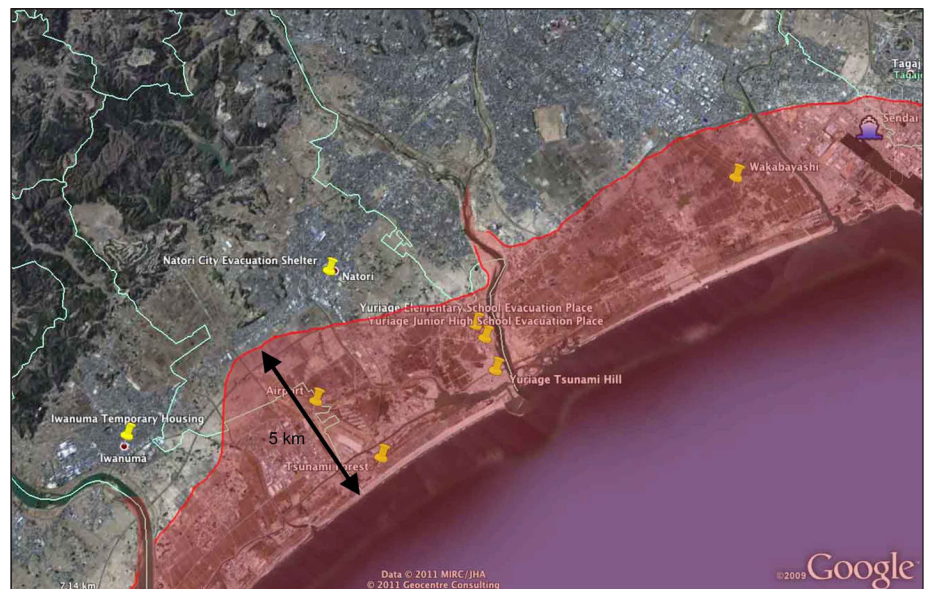
Figure 15. Approximate inundation area in Sendai, Natori, and Iwanuma Cities. Pins mark the locations of Wakabayashi, Yuriage, and the Sendai Airport, discussed in the text. The tsunami deposits transect is close to the black arrow where the tsunami penetrated about 5 km.

a much larger areal extent was inundated (see Table 1). Much of the inundation zone was agricultural and the population density was low, but there were two notable exceptions in the city limits: the Sendai Airport area and Yuriage, close to the Natori River.

Located within 800 m of the coast, most of Yuriage was inundated. Like Higashimatsushima, Yuriage was attacked from several directions: the coast, the river, and a canal that cut off the most exposed area of the community from ready access to higher ground (Figure 16), and few structures exceeded three stories

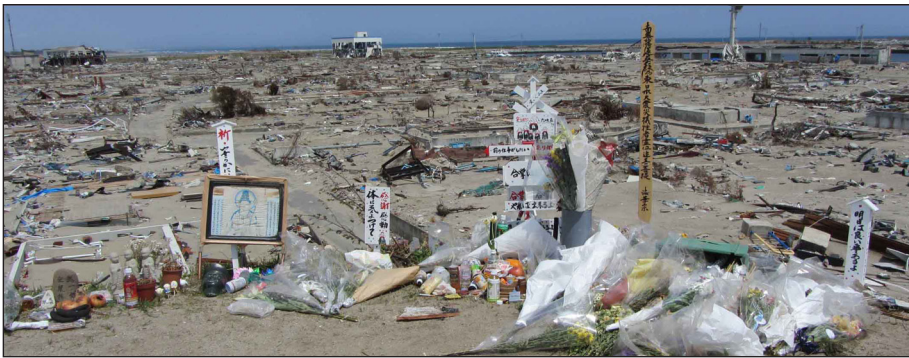
Figure 16. View from the top of the Yuriage memorial hill shown in Figure 15 (photo: L. Dengler).

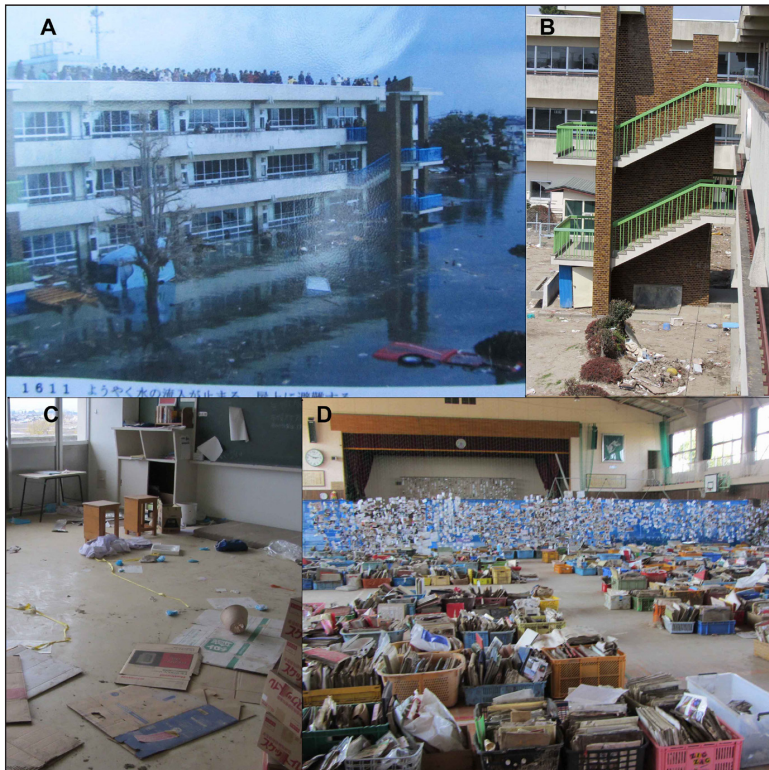
Figure 17. The Yuriage Elementary School evacuation site. Clockwise from upper left: A) photo taken at 4:11 p.m. during the peak of inundation (photo from the Memory Hall); B) detail of the exterior stairs; C) classroom that was used as a sleeping place for evacuees; D) the Memory Hall in the elementary gymnasium (photos: L. Dengler).

in elevation. The junior high and elementary schools had been designated as vertical evacuation sites. Figure 17A shows the elementary school with several hundred people assembled on the roof at the peak of inundation about an hour and 25 minutes after the earthquake. Many schools like the Yuriage Elementary School were designed with external stairways (Figure 17B) for easy

This school, like many other evacuation sites in the Tohoku area, was not equipped to serve the needs of people stranded for many days. Neither food nor water was stored on the premises, nor were blankets or bedding; there were no sanitary facilities and no access to first aid or emergency medical care. After the earthquake, winter temperatures were close to 0° C in much of the Tohoku region. Some elderly and injured tsunami survivors succumbed to the difficult conditions after extended time at such evacuation sites.

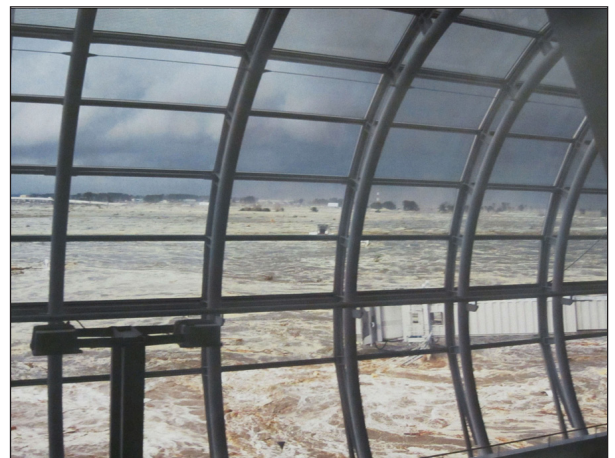
Figure 18. View out the third floor windows of the Sendai Airport during the tsunami (photo from Sendai Airport display).

Sendai Airport served as a vertical evacuation site for passengers, staff, and nearby neighbors (Figure 18). Although a security guard told employees that a tsunami was expected within 30 minutes, many believed there was no tsunami hazard at the site, although it is located within the mapped tsunami inundation zone.

The earthquake caused nonstructural damage at the airport, and, initially, security personnel attempted to assign people to floors, with those on the first floor not allowed on the upper floors. It took two days before helicopters evacuated stranded passengers and neighborhood residents, and at least some of the staff walked out of the inundation zone through standing water more than half a meter deep in some places.

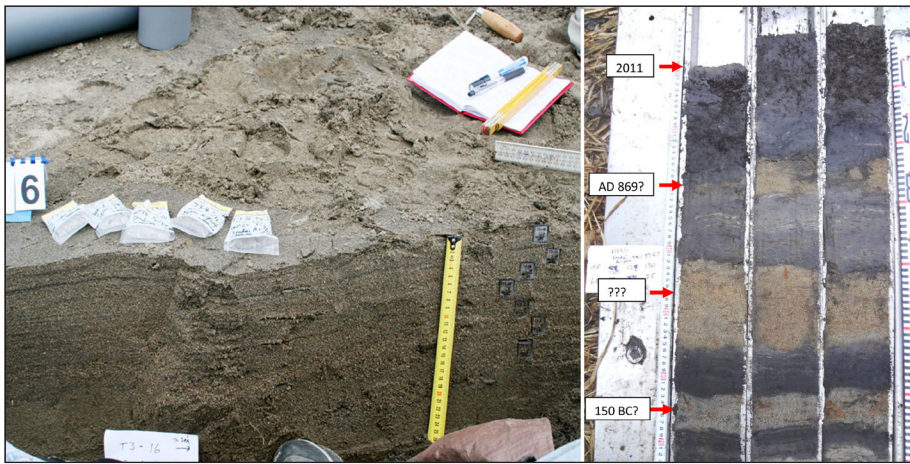
Figure 19. Wall of excavated trench from the line north of the Sendai Airport. Rectangular markers on right show locations where sediment samples were collected for further analysis (left photo: B. Jaffe; right photo: R. Wilson).

earlier deposits (Figure 19). Archeologists studying early human habitation on the Sendai plain have excavated a trench about 4 km inland of Arahama and 10 km north of the Airport. That trench shows a similar stratigraphy to the gouge cores. A large deposit dated to about 150 BCE may have been responsible for a temporary hiatus in rice cultivation in the region (Wilson, 2011). Considering the tsunamis in historic time, the paleotsunami deposits, and an older tsunami deposit found in some locales dating back about 3,000 years before the present, the average recurrence of great tsunamis on the Sendai plain appears to be on the order of 1,000 years (Minoura et al., 2001; Sawai et al., 2008).

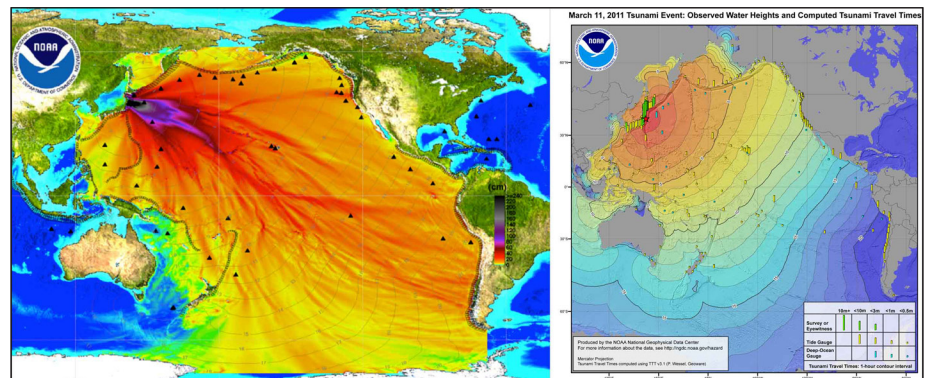
Figure 20. Left: computed maximum tsunami amplitudes throughout the Pacific (from NOAA PMEL). Note higher amplitude peak directed to northern California and southern Oregon. Right: tsunami travel times and measured water heights (NGDC, 2011).

The earthquake generated a tsunami that affected the entire Pacific basin (Figure 20). Tsunami warnings and advisories were issued by the Pacific Tsunami Warning Center (PTWC), the West Coast Alaska Tsunami Warning Center (WCATWC), and other national warning centers. The largest water heights outside of Japan were recorded in Crescent City, California (2.49 m recorded on a tide gauge, 3 m from eye witness accounts). Two other tide gauges on the U.S. West Coast recorded heights in excess of 2 m. Similar water heights were recorded at

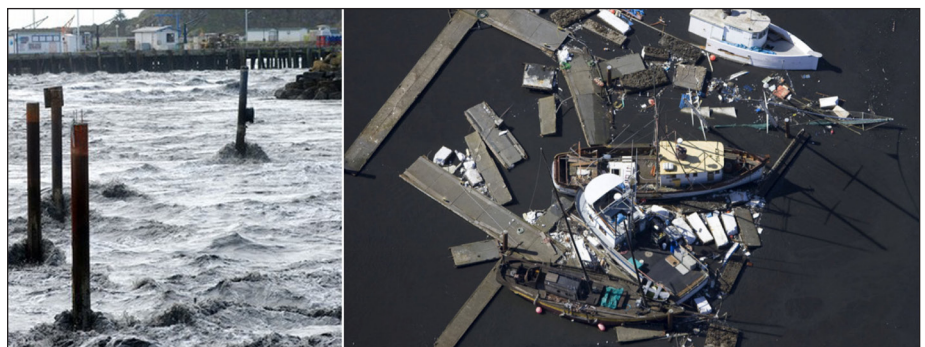
Figure 21. Crescent City, California. Left: the inner boat basin during the tsunami. Right: damaged docks and boats (photos: R. Hiser).

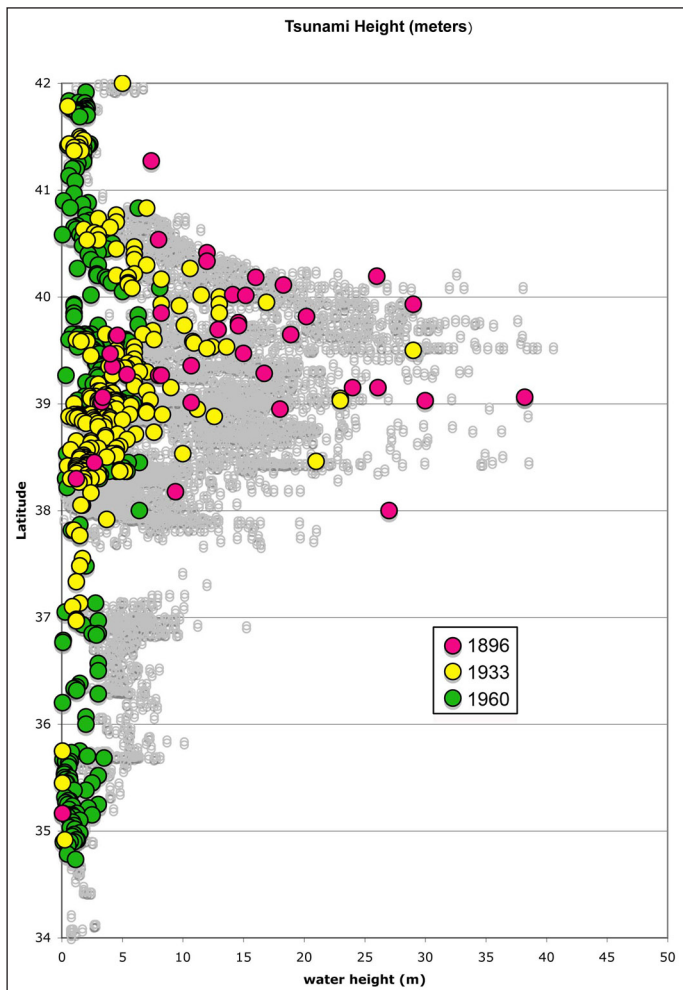
Figure 22. Historic tsunami water heights along the Tohoku coast. Water heights from the 1896 Meiji tsunami (red), 1933 Showa tsunami (yellow), and 1960 Chilean tsunami (green) are superimposed on the 2011 water levels (data from NGDC).

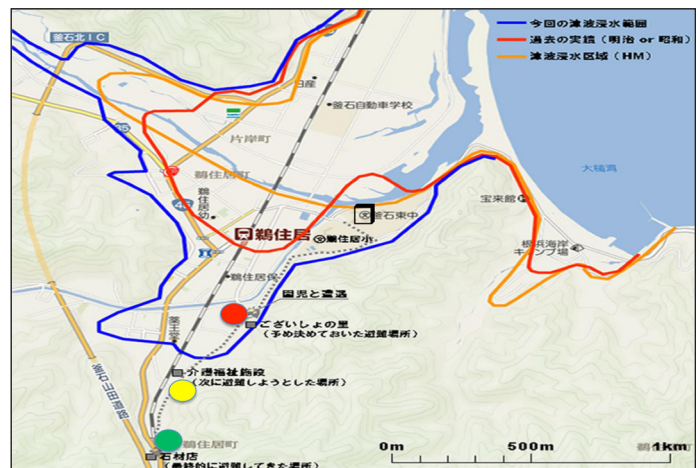
Figure 23. Evacuation and inundation map of Unosumai Town near Kamaishi. The orange line shows the evacuation area, the red line is the approximate inundation from the 1896 and 1933 tsunamis, and the blue line is the 2011 inundation (source: Mainichi Newspaper).

2) Limitations of published hazard maps. All coastal communities used the tsunami hazard assessment to develop inundation and evacuation maps. Figure 23 shows the evacuation map for Unosumai Town located near Kamaishi City. The 1896 and 1933 tsunamis flooded the town to the red line. Seawalls and large river dikes had been constructed since 1933 and were believed to be able to prevent the level of flooding seen previously. The hazard map, including the mitigating effect of the seawall, is shown by the orange line. The actual inundation in 2011 (blue line) exceeded both the historic inundation and the mapped hazard areas. A study done by *Mainichi Newspaper* (Sugimoto, 2011) reported

485 deaths in Unosumai, 419 of which (86%) had residences within the 2011 inundation area, but outside of the mapped hazard area.

In Unosumai, over 500 students from the junior high and elementary schools successfully made it to high ground (*Asahi Shimbun*, 2011b). Both schools were located just outside of the mapped hazard zone, and the students in the elementary school had been taught to go to the building's third floor after an earthquake. At the adjacent junior high school, students and staff had been taught to evacuate. When the elementary students saw the older students evacuating, they joined them, the older students assisting the younger ones. The group first headed to a location well outside of the mapped zone (red circle Figure 23), but changed

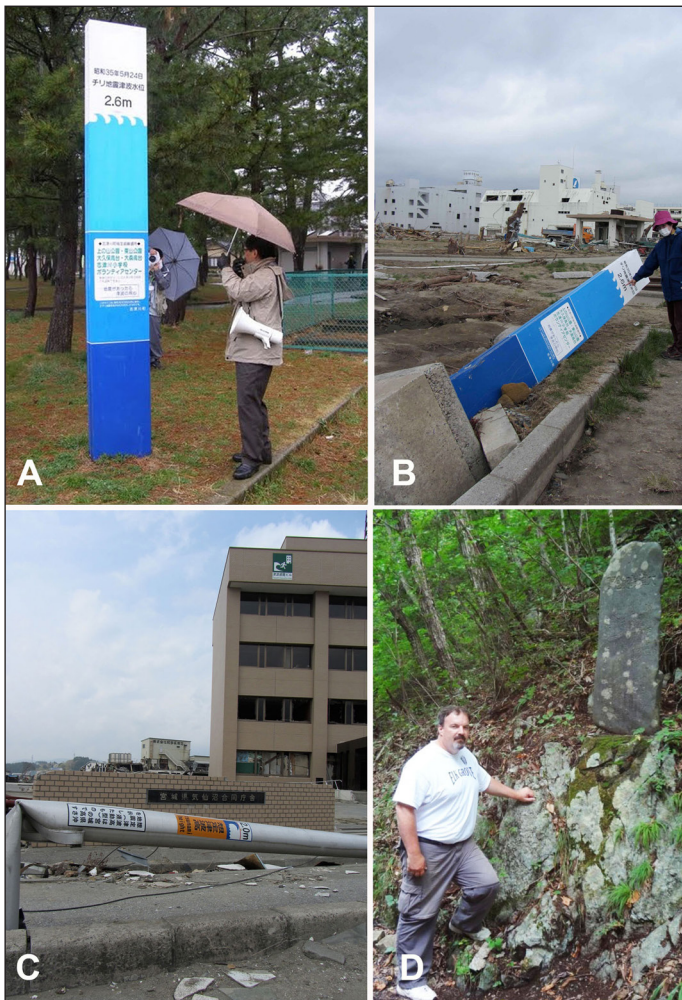
Figure 24. Water height markers. A) Marker commemorating the 2.6 m height of the 1960 Chilean tsunami at Minamisanriku Town (2010 photo courtesy of J. Bourgeois). B) The same marker in May 2011 (photo: L. Dengler). Water height at this location was over 15 m. C) Pole with expected 2 m tsunami height in Kesennuma City (photo: L. Dengler). Tsunami height reached the 3rd floor of the evacuation building in the background. D) Tsunami stone commemorating the height of the 1896 tsunami in Aneyoshi Bay (photo: B. Jaffe).

ual reminders of the height of past tsunamis or the expected highest water level (Figure 24). At Minamisanriku, a series of monuments and statues commemorates the 1960 Chilean tsunami (Figure 24A). The 2011 tsunami exceeded the 1960 water levels by more than 12 m (Figure 24B). At Kesennuma, the modeled tsunami height was printed on light poles as a visual reminder of the hazard (Figure 24C). The actual tsunami at this location was about 10 m higher.

10 m above the inundation zone, and no houses in Aneyoshi Village were flooded. More than two dozen tsunami stones have been identified in the Tohoku region, and preliminary reconnaissance suggests that about 20% were flooded in 2011 (Sugimoto, 2011). Unraveling the stories behind the stones will require careful investigation, as the original intent of the stone is not always clear, nor is whether it is still located in its original position, or how people understood its meaning.

A number of media stories have described tsunami stones that mark safe areas based on past tsunami heights (Fackler, 2011). Figure 24D shows the tsunami stone in Aneyoshi Bay, reputed to have been erected after the 1896 Meiji tsunami, directing people to build houses above its elevation. Although Aneyoshi Bay had the highest runup (38.9 m) in the 2011 tsunami, the stone was about

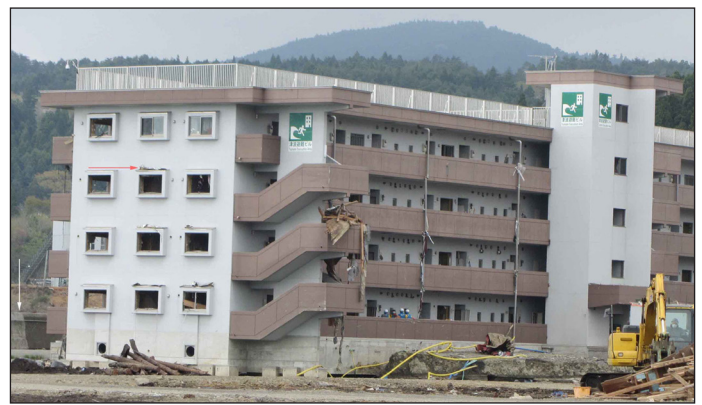
Figure 25. Tsunami evacuation building in Manamisanriku (B on map, Figure 8). The building is adjacent to the sea-wall (white arrow on the left). The tsunami left debris on the fourth floor windows (red arrow) (photo: L. Dengler).
