The 1906 Earthquake on California's North Coast

by Lori Dengler

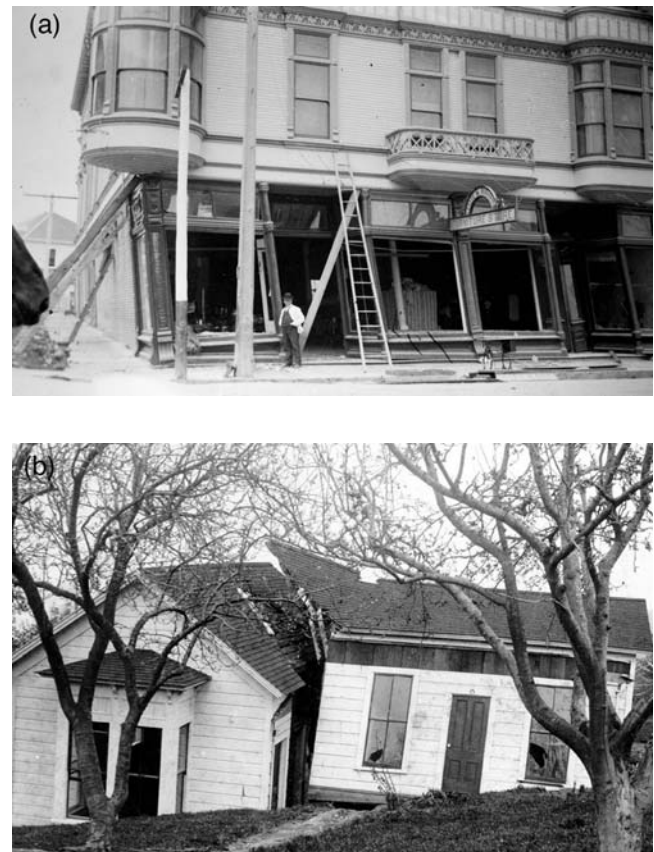
Figure 5. Damage to wood-frame buildings in Ferndale. (a) The Knights of Pythias Hall, repaired after the earthquake, was eventually replaced by a gas station. (b) Unidentified home. Photos by E. Garrett, courtesy Peter Palmquist.

The other structures in Ferndale were of wood-frame construction. Of the 40 wooden commercial structures in the town, 12 suffered twisting and wrenching. The largest wood structure in town, the Knights of Pythias Hall (Fig. 5a), was severely twisted and required shoring to prevent collapse. According to the *Ferndale Enterprise*, almost every window in town was broken, many homes were knocked off foundations, and porches and chimneys collapsed (Fig. 5b). Plaster damage was common, and all merchandise within buildings scattered. There were no serious injuries, although the *Enterprise* noted a number of close escapes. Damage was at least as extensive as in the 1992 Cape Mendocino earthquake, where Ferndale was assigned an MMI VIII (Reagor and Brewer, 1992; Oppenheimer *et al.*, 1993).

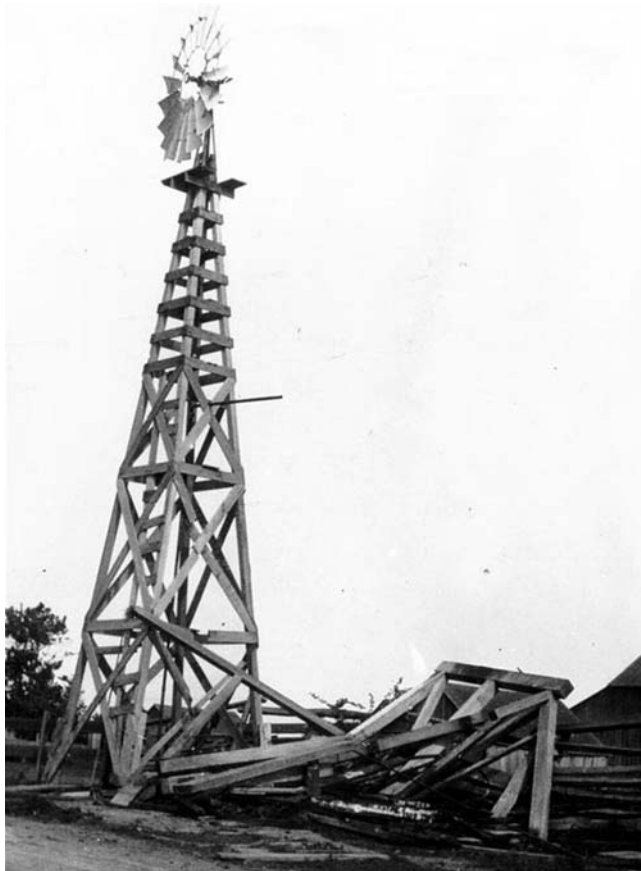
Figure 6. Twin windmills in the Eel River Valley; mill on the right has collapsed. Photo by E. Garrett, courtesy Peter Palmquist.

The *Ferndale Enterprise* notes that fewer than 2% of chimneys elsewhere in the Eel River Valley remained intact and that county water tanks and windmills were thrown to the ground (Fig. 6). Cracks, fissures, lateral spreads, and other liquefaction effects were widespread in the lower Eel River Valley, west of Fortuna. The islands near the mouth of the Eel River were particularly hard hit. The *Enterprise* notes, “Cock Robin Island came in for its share of the shake, chimneys being torn down and many holes and cracks in the ground made. The same destruction visited Cannibal Island, it being said that the land there that was quite high before the shake-up is now lowered from one to 10 ft, while low places have been filled up. In many instances where the ground opened a kind of black sand or sediment oozed forth, showing that it must have been thrown from the very bowels of the earth. On the Hamner ranch on the island, under lease to Rasmus Nielsen, we are told that this sand or sediment was very warm and that smoke arose from it for several hours after the convulsion.” At Port Kenyon, 4-km northeast of Ferndale, the *Ferndale Enterprise* reported that several acres of land settled several feet. All along the Salt River (part of

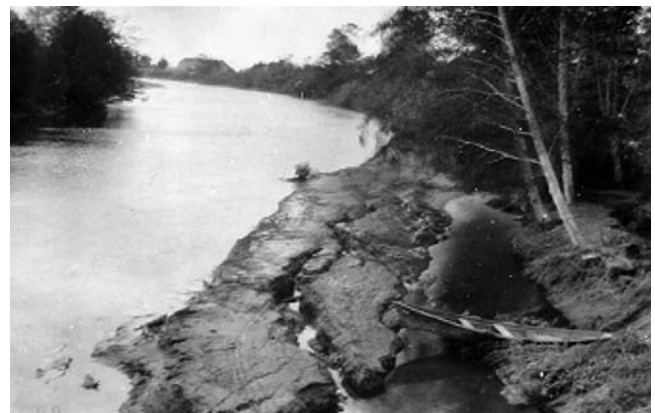
Figure 7. Liquefaction on the Salt River, Eel River Valley. Photo by E. Garrett, courtesy Peter Palmquist.

the Eel River estuary), land slid into the river and was reported cracked for distances of several hundred feet on either side (Fig. 7). At Centerville Beach near the mouth of the Eel River, the *Ferndale Enterprise* reported a half-mile-wide landslide into the Pacific near Oil Creek, obstructing the view between the Cape Mendocino and Table Bluff lighthouses. All reports suggest that ground motions throughout the Eel River Valley as far east as Grizzly (about 3-km south of Fortuna) were at least as strong as at Ferndale and should be assigned an intensity of VIII.

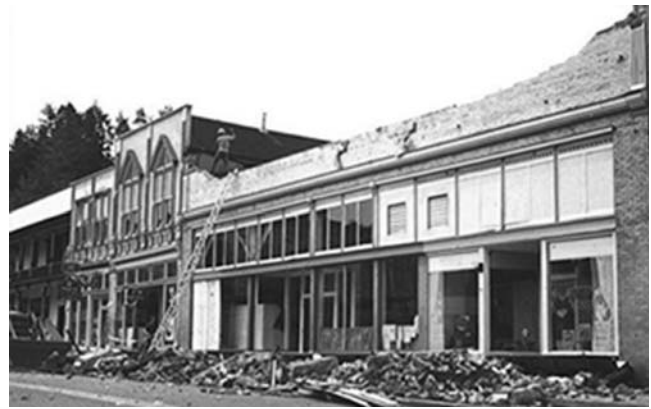
Figure 10. History repeats itself in Ferndale. 339 Main Street (now the Valley Grocery) 86 yr later. Photograph taken 25 April 1992 after the Cape Mendocino earthquake, by K. Bayless.

pare the two earthquakes. Seventy percent of the downtown buildings on Main Street that experienced the 1906 earthquake still existed in 1992. In 1906, almost all of the buildings on Main Street suffered some damage. The two brick buildings were badly damaged (see Fig. 4) and approximately 25% of the wooden buildings on Main Street were severely twisted (Fig. 5a). In 1992, few of the wooden buildings on Main Street suffered structural damage. Only one brick building remained in the town. In 1906, the building was the brand new General Mercantile. The entire brick parapet collapsed in the earthquake, and all the windows were broken (see Fig. 4a). The building was repaired, and by 1992, had become the Valley Grocery. The Cape Mendocino earthquake produced a similar, although not as extensive, collapse to the parapet wall (Fig. 10).
